2006 Boston Whaler 24 Outrage

Report of Marine Survey

FILE NUMBER:	130808100
TYPE OF SURVEY:	Pre-Purchase for Buyer
OVERALL VESSEL RATING:	**** AVERAGE
ESTIMATED MARKET VALUE:	48,000.00
ESTIMATED REPLACEMENT COST:	70,000.00
BUILDER:	Boston Whaler
YEAR BUILT:	2006
MODEL OF VESSEL:	240 Outrage
HULL IDENTIFICATION NUMBER (HIN):	US-BWC
OWNER:	N/A
DATE/TIME OF SURVEY:	August 08, 2013 8 am
HULL MATERIAL:	Solid FRP (Fiber Reinforced Plastic)
HULL TYPE:	Deep - V
LENGTH OVER ALL (L.O.A.):	23' 9"
BEAM:	8' 6"
DEADRISE AFT:	22 Degrees
DRAFT:	18"
DISPLACEMENT:	4400 lbs.
OVERHEAD CLEARANCE:	8' 10"
PROPULSION SYSTEM:	Single outboard
FUEL TYPE:	Gasoline.
FUEL CAPACITY:	150 Gallons
DC POWER:	12 Volt system
FRESH WATER CAPACITY:	20 Gallons
HOLDING TANK:	3 Gallons
INTENDED USE/BUYER:	Recreational near coastal fishing
BUYER'S EXPERIENCE:	Not Determined.
INTENDED CRUISING AREA:	Near coastal and inland Florida.

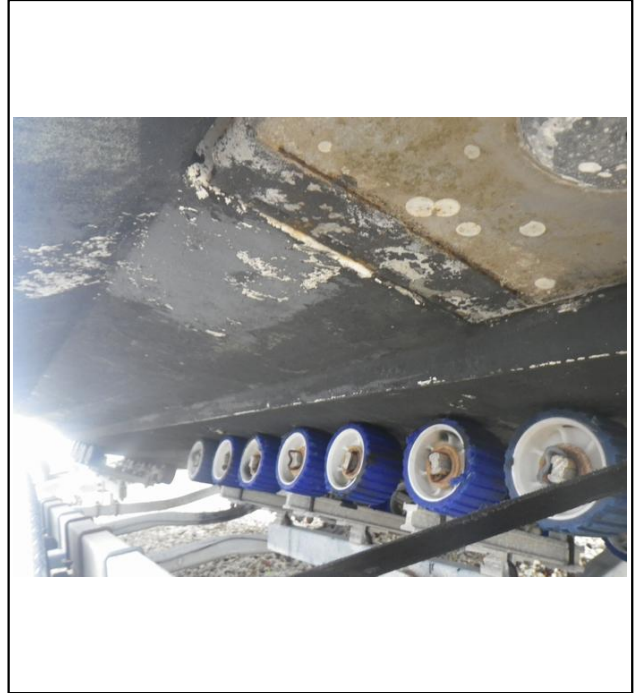
Black ablative bottom paint in serviceable condition. Recommend sanding and repainting for next season.

Bottom should be painted

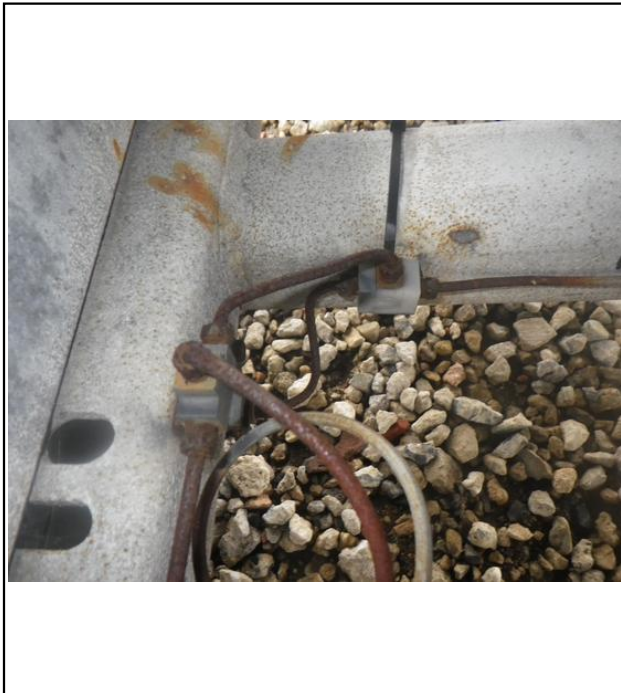
Tidewater galvanized roller trailer with manual cable winch, trailer jack. 4 Wheel disc brakes, hubs with grease fittings. VIN # 5LFGR27288P003867. The lights and tires are in good condition. Some corrosion was sighted to the brake lines and rotors.

Rusted brake lines

Tidewater galvanized roller trailer with manual cable winch, trailer jack. 4 Wheel disc brakes, hubs with grease fittings. VIN # 5LFGR27288P003867. The lights and tires are in good condition. Some corrosion was sighted to the brake lines and rotors.	
FINDINGS	RECOMMENDATIONS
Some corrosion was sighted to the brake lines and rotors.	<i>Inspect and repair as necessary</i>

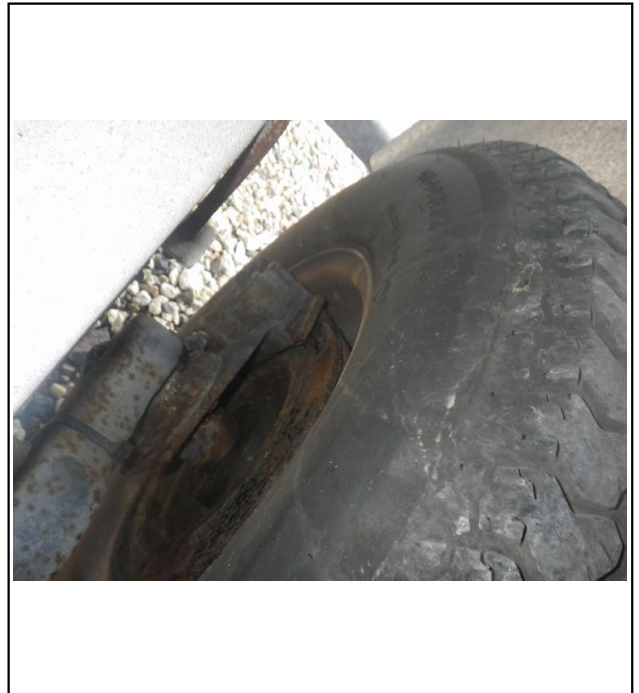
Rusted rotors

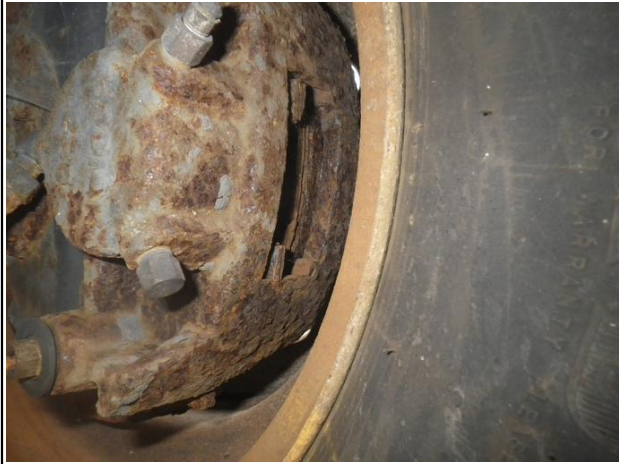
Calipers with some rust

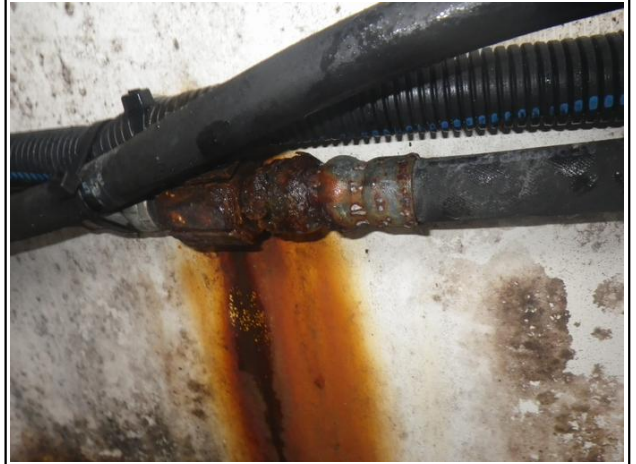
Reinforced flexible hose, with metallic fittings. Some excessive corrosion was sighted to a fitting in the aft bilge.

Corroded steering line fitting

Reinforced flexible hose, with metallic fittings. Some excessive corrosion was sighted to a fitting in the aft bilge.	
FINDINGS	RECOMMENDATIONS
Some excessive corrosion was sighted to a fitting in the aft bilge.	<i>Investigate further and repair or renew as necessary.</i>

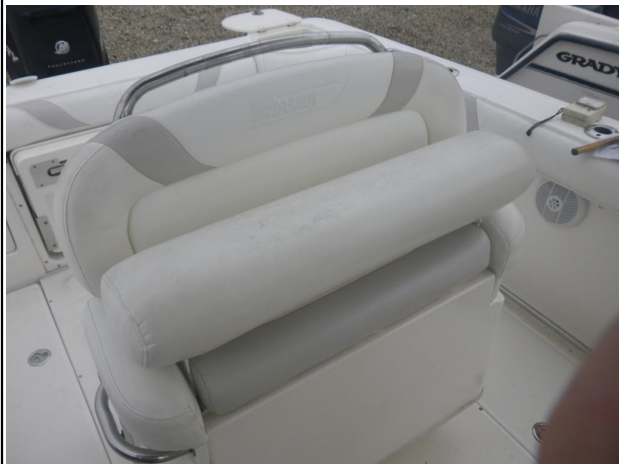
Fold away aft bench seat, helm leaning post/bolster forward console seat. White vinyl needs cleaning and no forward cushions were sighted.

Vinyl needs cleaning

Fold away aft bench seat, helm leaning post/bolster forward console seat. White vinyl needs cleaning and no forward cushions were sighted.	
FINDINGS	RECOMMENDATIONS
White vinyl needs cleaning and no forward cushions were sighted.	<i>Clean vinyl and locate front cushions if included with the boat.</i>

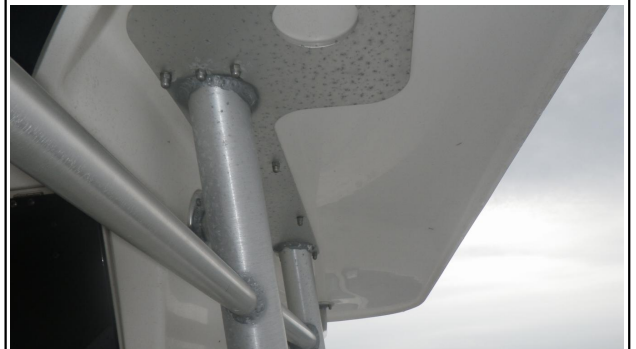
The vessel is equipped with a factory FRP hard top(low moisture and good soundings) using aluminum tubular supports. Well secured all welds are good. The metal needs polish

Aluminum needs polishing

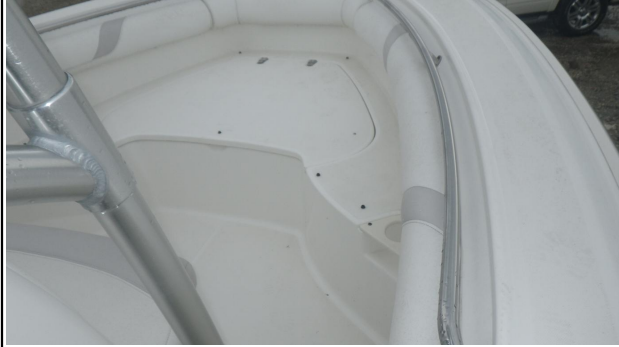
Missing forward cushions

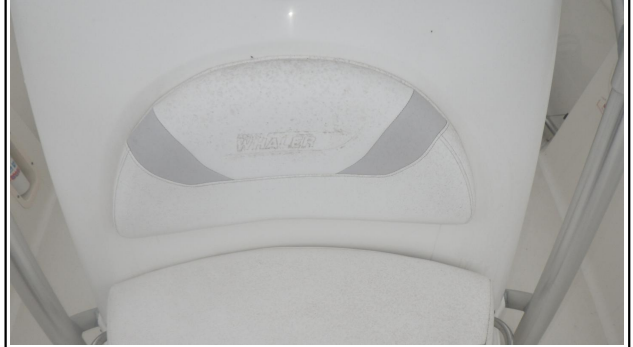
Vinyl needs cleaning

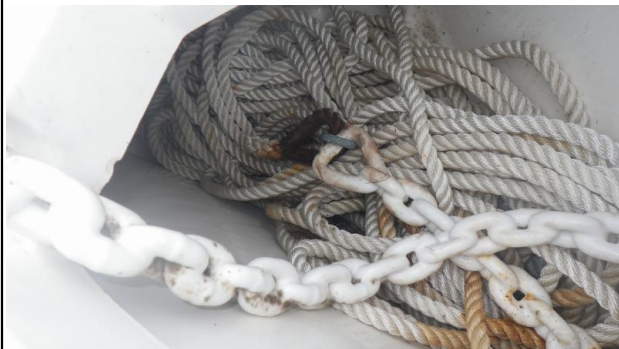
Thimble and U- shackle. The thimble is corroded.

Corroded thimble

Thimble and U- shackle. The thimble is corroded.	
FINDINGS	RECOMMENDATIONS
The thimble is corroded.	<i>Replace thimble.</i>

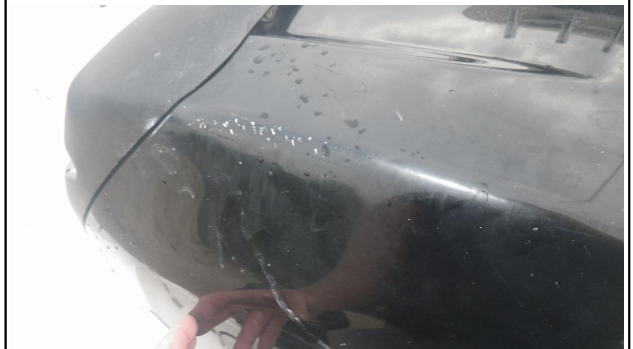
Water proof engine cowl **with some minor nicks and scratches.**

Nicks on engine cowl.
