Ulrick Marine
MARINE SURVEYOR AND CONSULTANT

2011 Cigarette 38 Top Gun

Report of Marine Survey

9/12/2022

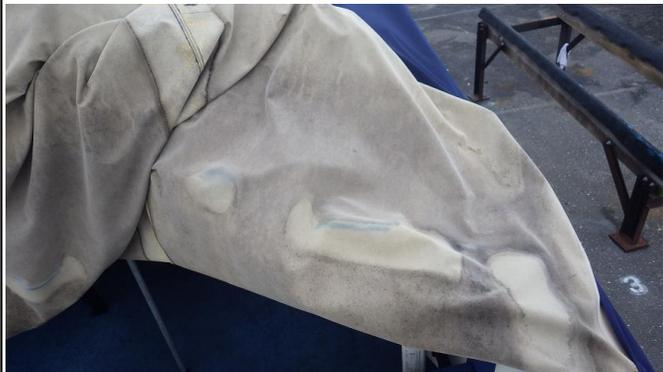
Full boat. Good condition. Some mold was sighted on the underside

Mold on the underside of the boat cover

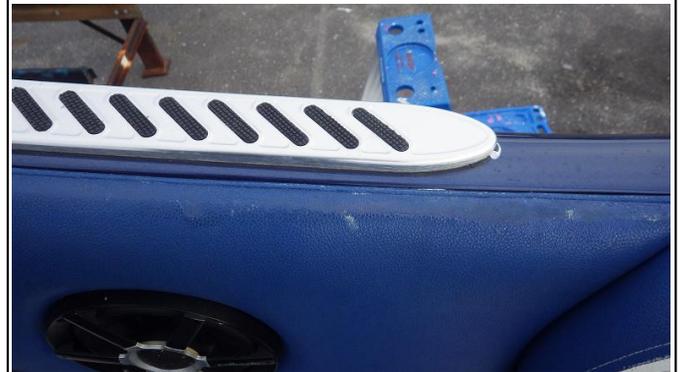
Large single level cockpit with helm to starboard (the helm is equipped with a full Livorsi gauge package and controls). Port and starboard lockers. Snap in carpets over a mat. The vinyl coaming tops is slightly worn from the boat cover.

Worn coaming tops

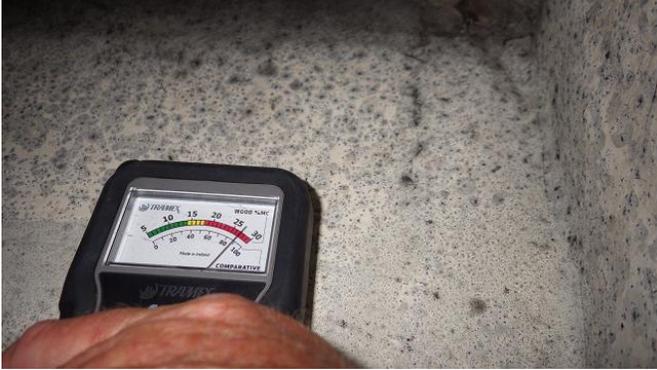
Athwartships reinforcement enhanced by encapsulated bulkheads and web frames bonded to the hull with FRP (fiber reinforced plastic). High moisture was detected at the midship and engine space bulkheads. Serviceable condition.

High moisture was detected at the midship and engine space bulkheads.

High moisture at the midship bulkhead

FINDINGS	RECOMMENDATIONS
High moisture was detected at the midship and engine space bulkheads.	Consult a fiberglass expert to determine the extent of the moisture or if any exist.

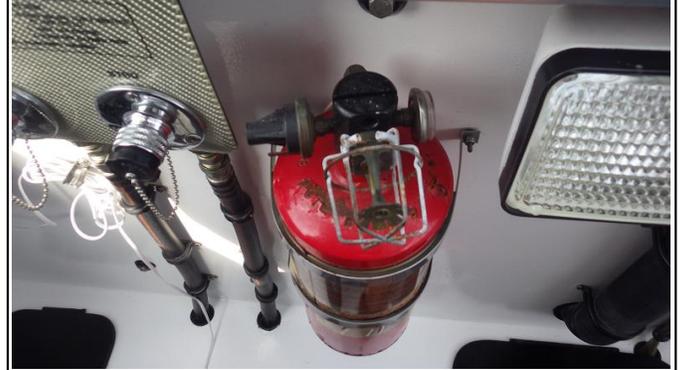
Fire boy Halon in engine room automatic is charged, some rust beginning to form on the bottle. Needs current inspection.

Halon bottle developing rust

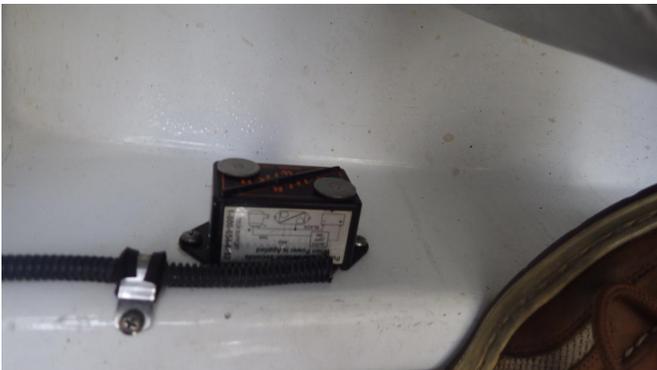
The high water alarm did not work when tested	
FINDINGS	RECOMMENDATIONS
The high water alarm did not work when tested	Consult a marine technician and repair to ABYC standards

High water alarm inop

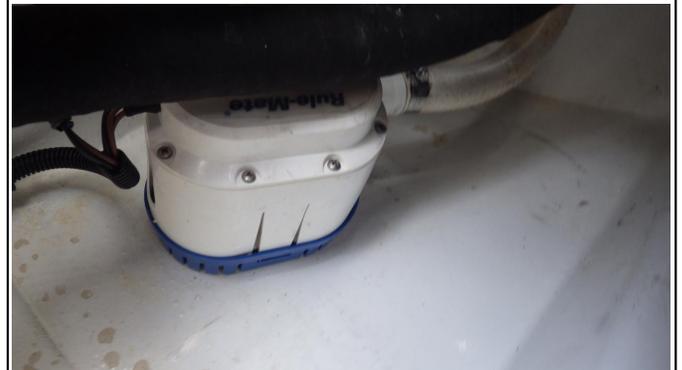
2 Rule 2000 Worked when tested. The water sensors did not shut off.	
FINDINGS	RECOMMENDATIONS
The water sensors did not shut off.	Investigate and repair to ABYC standards.

Bilge pump sensor sticks

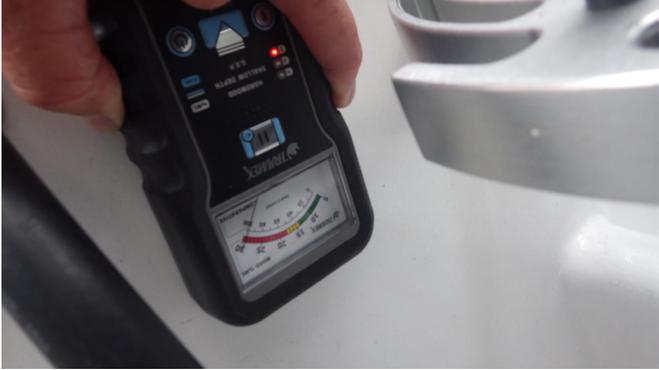
High moisture at the engine space bulkhead

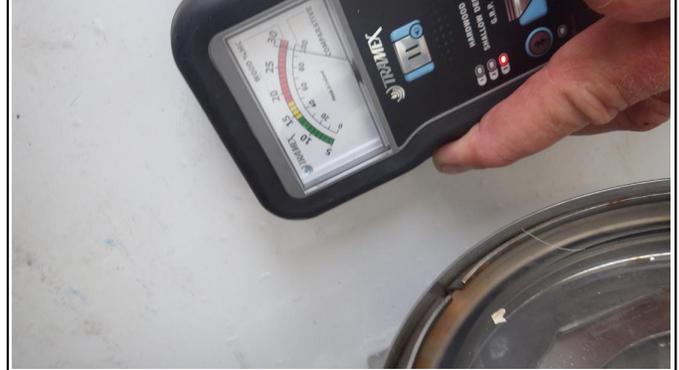
Hull stiffness provided by FRP longitudinal stringers. High moisture was detected in the engine space, a small void was detected at the port outside aft stringer

High moisture was detected in the engine space, a small void was detected at the port outside aft stringer

High moisture at the engine space stringers, minor void detected at the aft port side stringer

FINDINGS	RECOMMENDATIONS
High moisture was detected in the engine space, a small void was detected at the port outside aft stringer	Consult a expert to determine the extent if any moisture exists

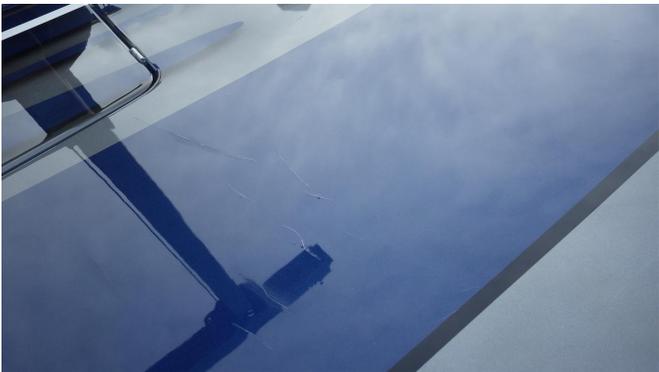
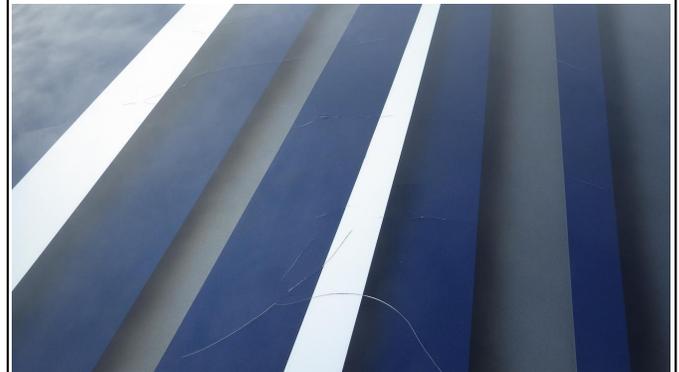
Smooth painted finish paint cracks were sighted midship. Low moisture and good soundings

Smooth painted finish paint cracks were sighted midship.

Deck paint cracks

FINDINGS	RECOMMENDATIONS
Smooth painted finish paint cracks were sighted midship.	Repair as necessary

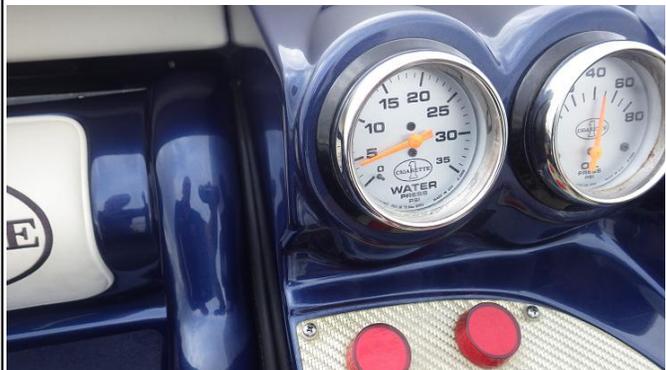
The port water pressure gauge did not work

Port water pressure gauge inop.

The port water pressure gauge did not work	
FINDINGS	RECOMMENDATIONS
The port water pressure gauge did not work	Replace the gauge
