Report of Marine Survey

"Cold mold Sample"

50 Carolina Custom

October 04, 2014

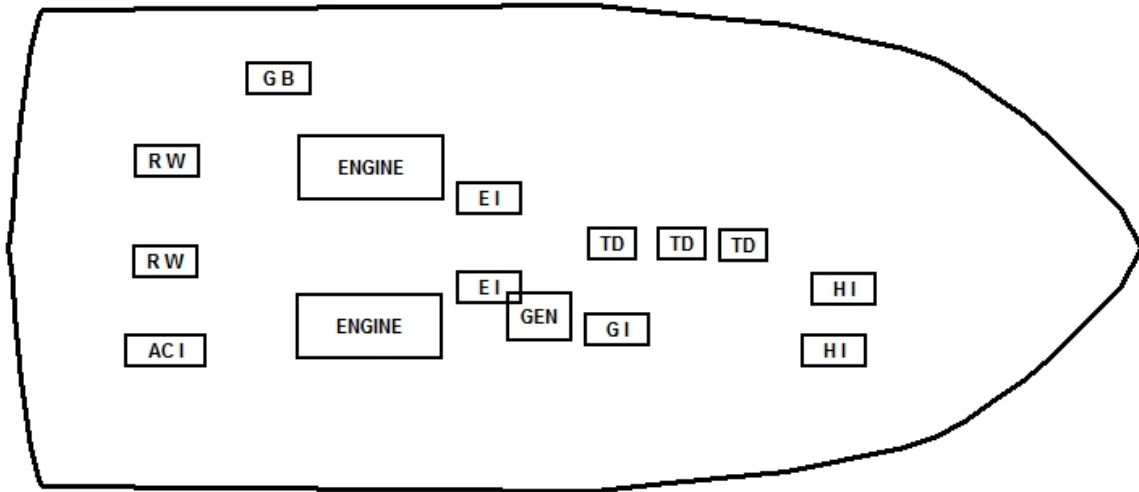
THRU-HULLS BELOW WATER LINE (DIAGRAM):

Abbreviation	Description
AC I	ac intake
E I	engine intake
ENGINE	Engine
G B	groundbar
G I	generator intake
GEN	Generator
H I	head intake
R W	raw water intake
TD	Transducer

**Red Icon(s) with white text indicates inoperable item.
